Autopsy of an Acid Copper Plating Bath: Dangers of Recycling

by Jim Economus and Ron Barauskas of EMS Analytical Labs

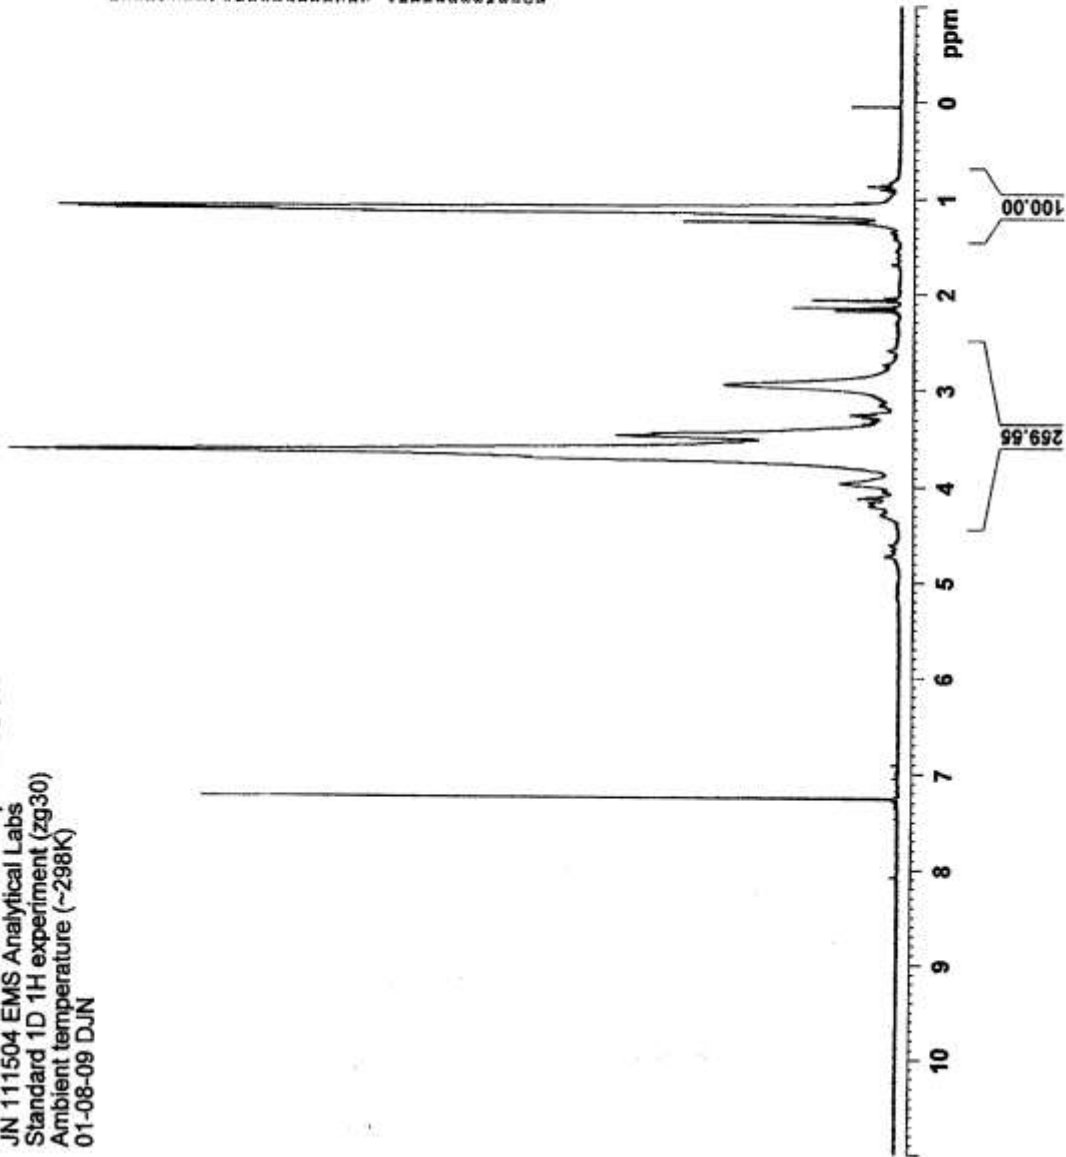
FIGURE 2

To match the phosphate ester, NMR (nuclear magnetic resonance) analysis was suggested. The results of that analysis eliminated the phosphate ester but provided a fingerprint for a poloxamer (Figure 2) that came from the sample. This is a family of non-ionic block copolymer surfactants that have high molecular weights. BASF manufactures a series of these compounds under the Pluronic[®] trade name. This information allowed us to identify one of the alternative oxide wetting agents as the closest match (Figure 3).

USP Poloxamer Solid RS Lot# F0G283
(83 mg in 1 mL CDC13, drop D2O, 3 uL TMS)
Standard 1D 1H experiment (zg30)
Ambient temperature, Spinning
01-12-09 HVH
